NACELLE DAMAGE DESCRIPTION (NDD) GUIDE AND EXAMPLES

—
23rd March 2017

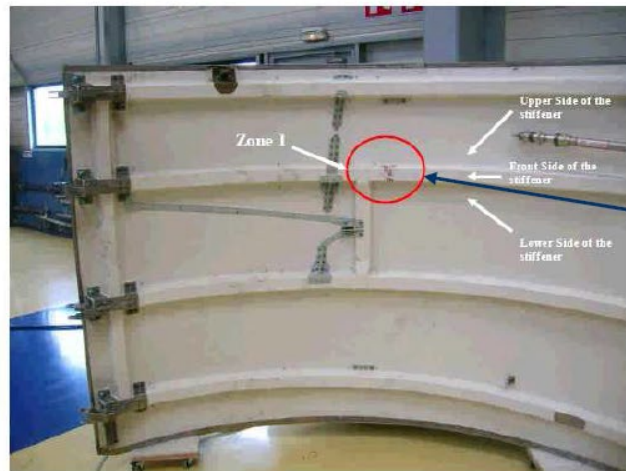
3.1 Example 1: cracks on composite structure

THE STIFFENER N° 2 HAS BEEN FOUND CRACKED ON THE FAN COWL AFTER DVI (DETAILED VISUAL INSPECTION)

NOTA : all dimensions are in millimeters

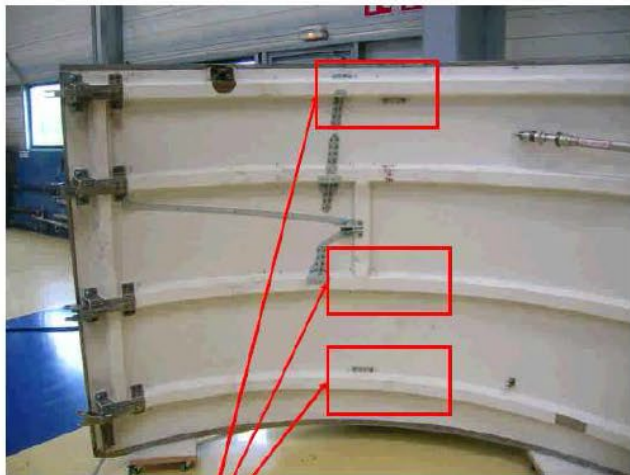
3.1 Example 1: cracks on composite structure

These areas on the three other stiffeners have been controlled by U-S inspection. They are free of any damage.

**THE OTHER STIFFENERS
AND THE OUTER SKIN HAVE
BEEN INSPECTED (ULTRA
SONIC), TO CONFIRM THE
DVI : THEY ARE FREE OF
DAMAGE.**

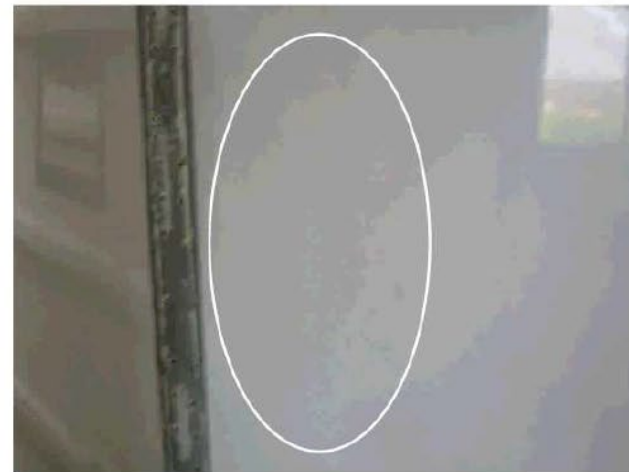
External skin : the external skin is free of damage (see following inspected areas)

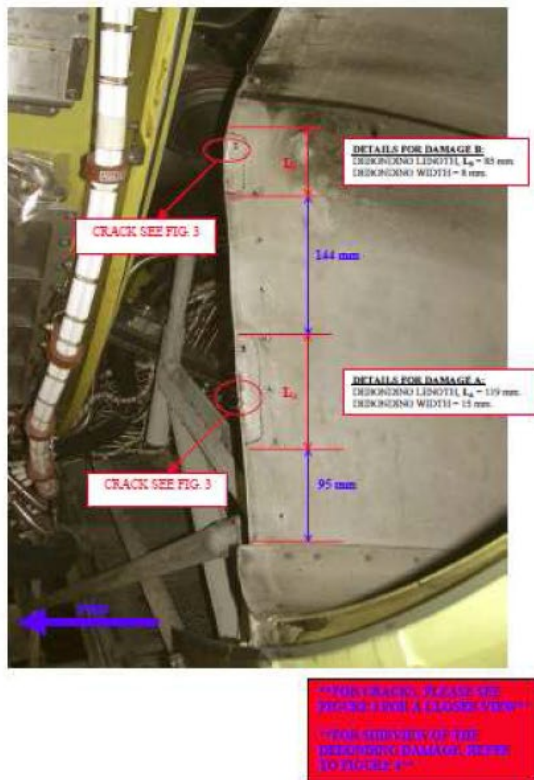
FIGURE 2. ACTUAL PHOTO OF THE DAMAGES

TAP TEST HAS BEEN PERFORMED AROUND THE 2 VISIBLE DAMAGES TO DETECT THE DISBONDED AREA.

THE DISBONDED AREA ARE LOCATED USING THE FLOW PATH FAIRING AS REFERENCE.

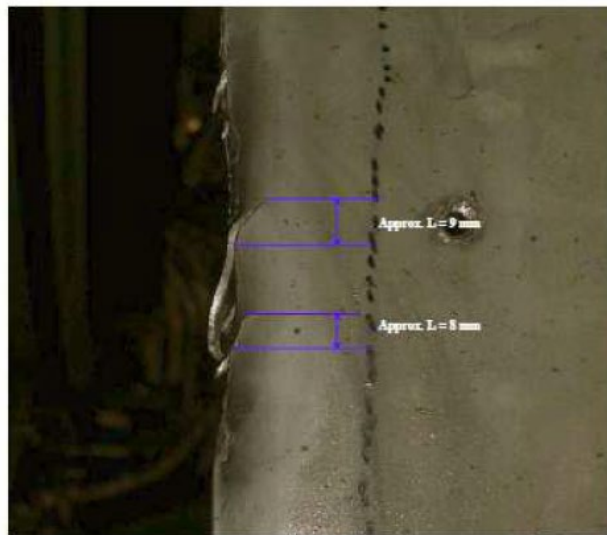
DAMAGE A

FLUORESCENT PENETRANT
HAS BEEN PERFORMED ON
BOTH DAMAGE FOR CRACK
DETECTION

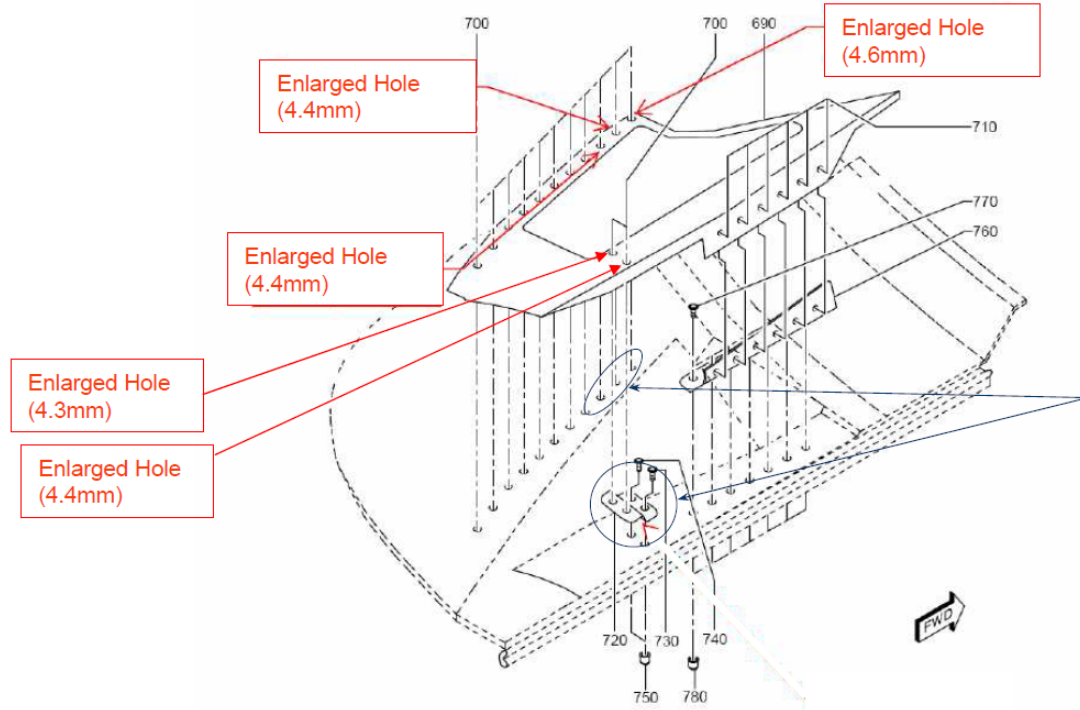
3.3 Example 3: Loose rivets on composite parts

**LOOSE RIVETS GENERALLY HAVE
CONSEQUENCES ON LOWER PARTS
OF THE ASSEMBLY**

**IN THIS CASE : METALLIC BRACKET
AND ACOUSTIC PANEL MUST BE
INSPECTED (MEASUREMENT OF
HOLES + NDT)**

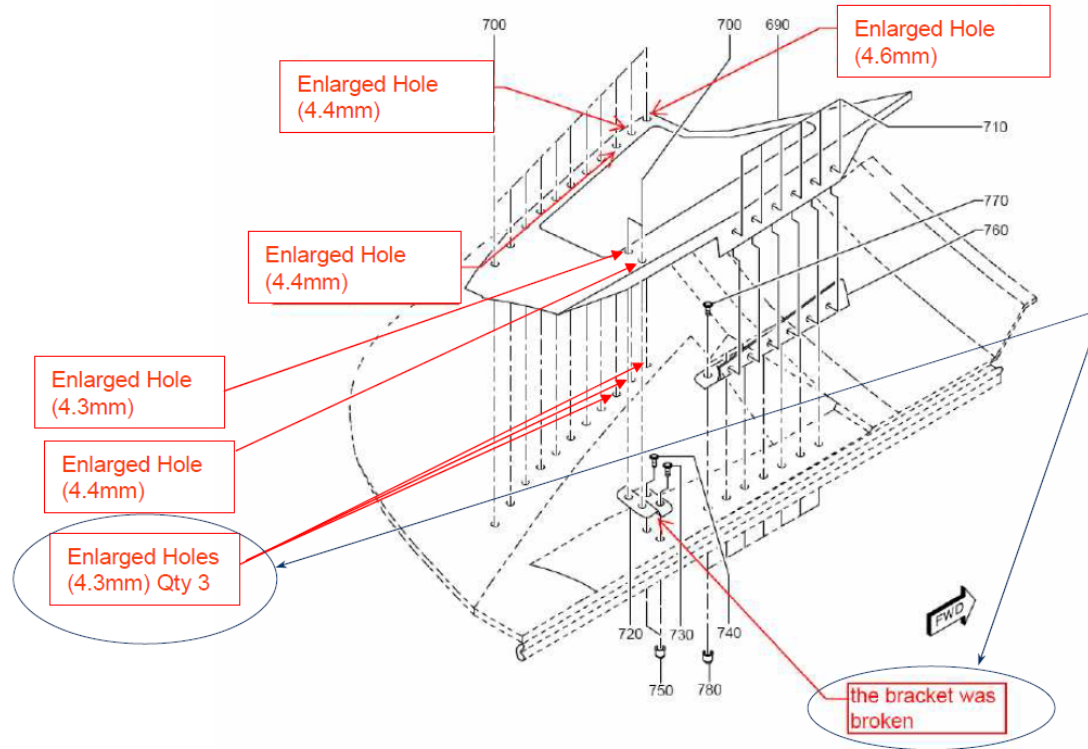
3.3 Example 3: Loose rivets on composite parts

**METALLIC BRACKET WAS FOUND
BROKEN, AND HOLES IN ACOUSTIC
PANEL WERE ALSO ENLARGED.**

**COMPOSITE PARTS WERE FREE OF
DELAMINATION.**
